DEFENDANT’S EXPERT REPORT

June 9, 2020

Robert Spindler

Glass on the UGAA project is an insulating glass unit with the following construction.

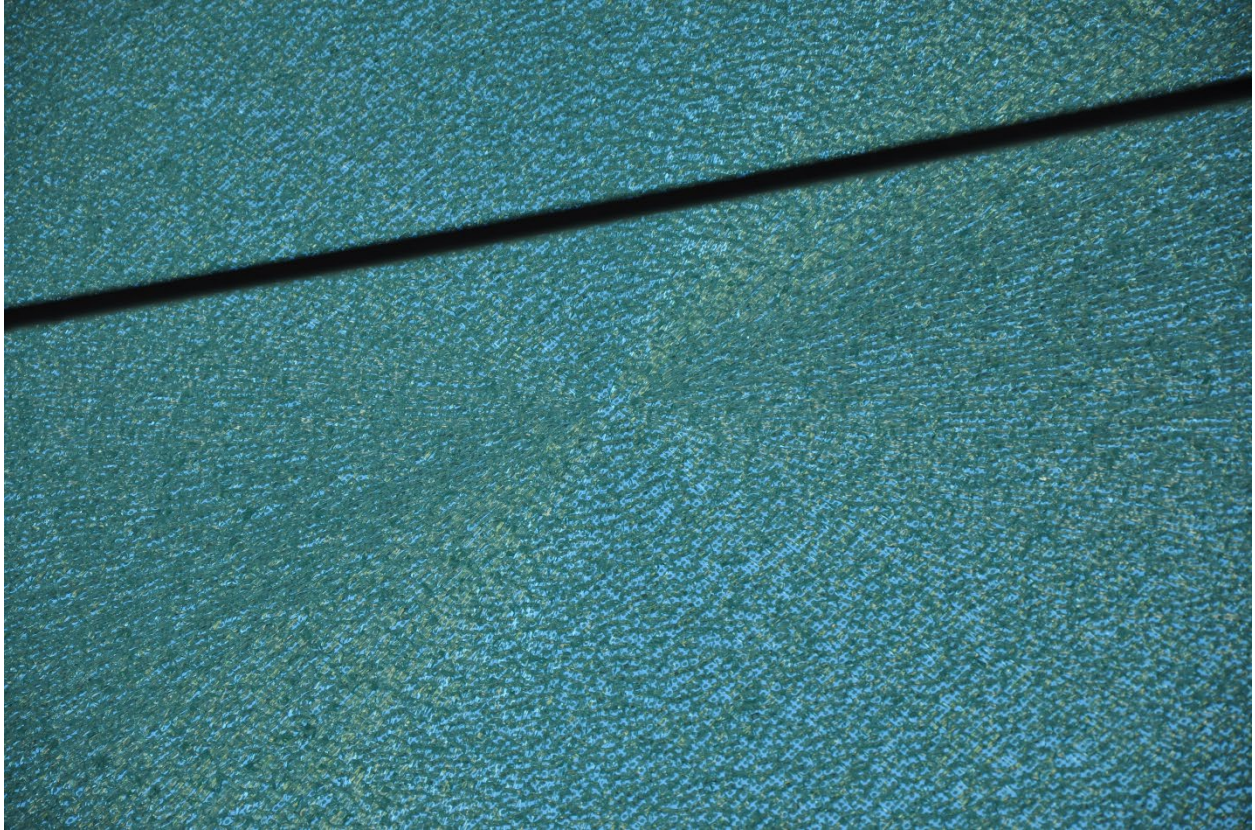
It is my opinion that the glass fracture shown in the photograph below, my experience on the UGAA project, my 50 years of experience in the glass industry, that I am 80 to 90% certain that the glass fracture in the photo below on the UGAA project was caused by a NiS stone inclusion.

Photograph of Tempered Glass Breakage at UGAA (Taken on 06-02-2020)

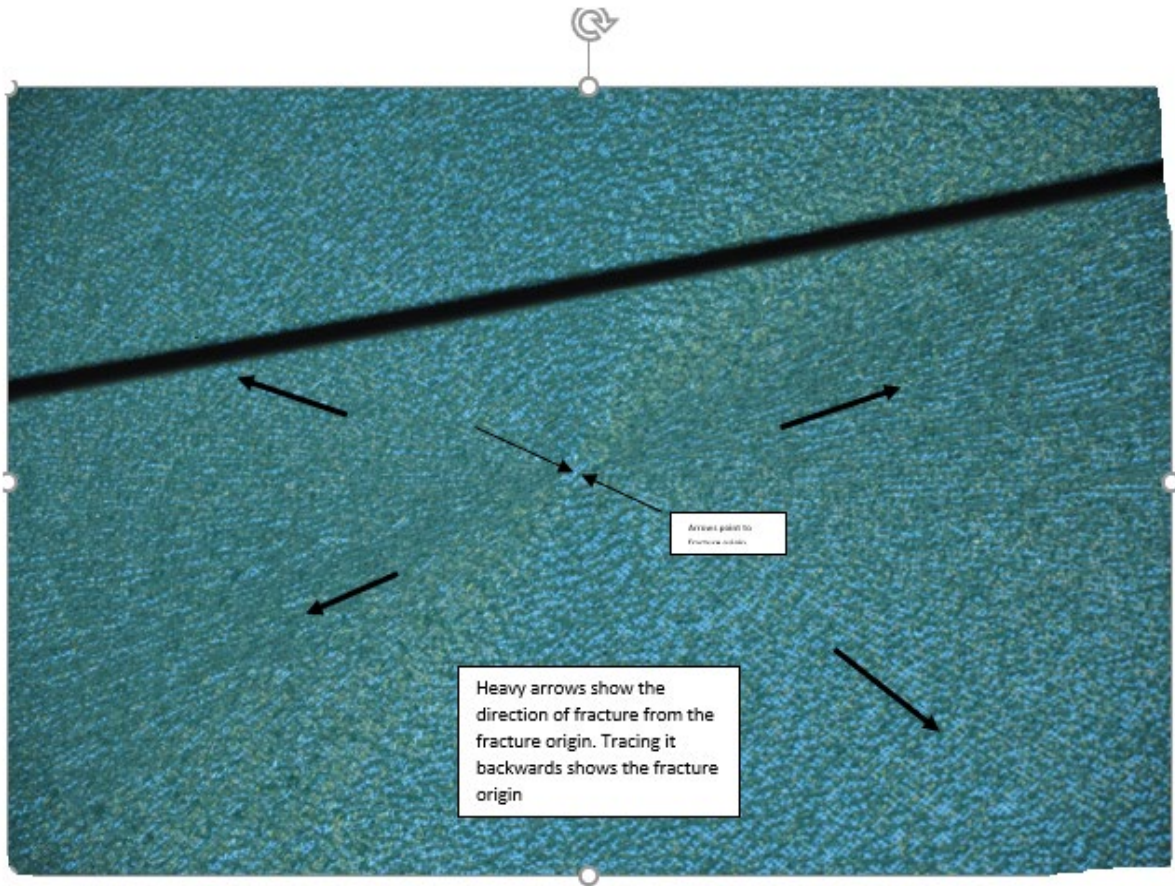
However, with that being said, tempered glass can fracture from a non-inspectable inclusion inside the central 58% of the glass thickness. This is noted as the tension layer in tempered glass. If a NiS stone is in annealed glass, breakage will not occur. However, in tempered glass, if the NiS stone is in the central tension section of the glass, it can in time expand and cause the glass to fracture. Many times, when the fracture of tempered glass occurs, a loud noise occurs that is the release of the tension layer energy in the glass. If the glass is not laminated or does not have a film on it, the fracture origin may not be found as the glass usually will fall out of the opening. However, if the glass is laminated or has a film on it, this keeps the fractured particles in place, and the fracture origin can be found. For a fracture in tempered glass caused by a NiS stone inclusion, the fracture origin can be determined as the fragments of the glass fracture emanated from the fracture origin. In the industry the fracture origins from a NiS inclusion are usually a 2 - 6 or 8 sided pieces of glass with each side being between $\frac{1}{2}$ to 1 inch long. Taking these 2 sections apart will show a NiS stone close to the center of the thickness in the glass, which is in the tension zone of the glass. The photo of the fractured glass, the origin, and the glass fracture pattern emanating from the fracture origin is indicated in the photo.

Photograph of Tempered Glass Breakage at UGAA (Taken on 06-02-2020) Showing Fracture Lines, and Fracture Origin.
